# **INDOOR AIR QUALITY ASSESSMENT**

**Chicopee Public Safety Building  
Emergency Operations Center/Board of Health Offices  
15 Court Street  
Chicopee, Massachusetts**

Prepared by:  
Massachusetts Department of Public Health  
Bureau of Environmental Health Assessment  
Emergency Response/Indoor Air Quality Program  
November 2002

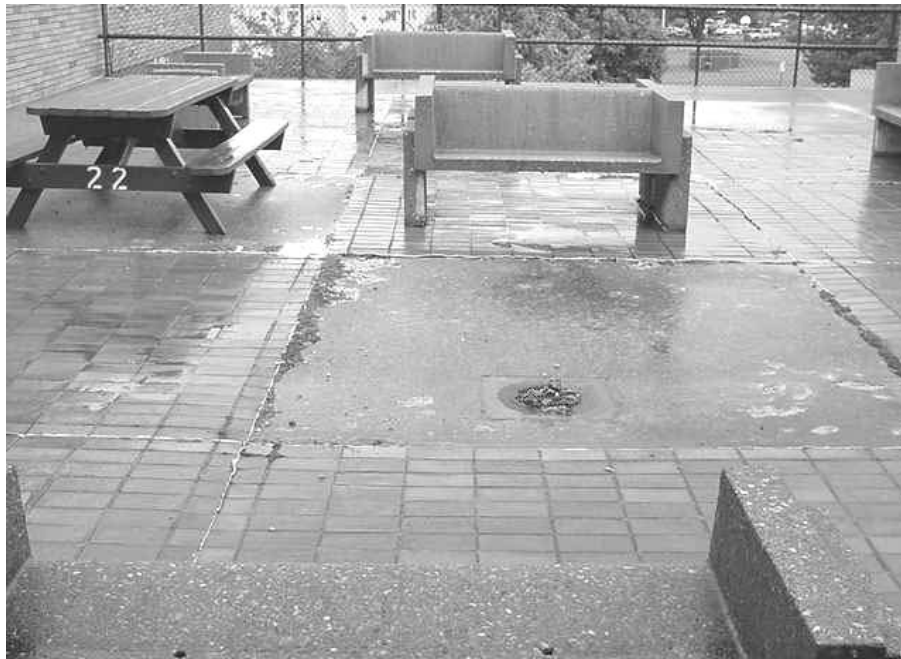
**Picture 1**

The CPSC was constructed in 1976. The EOC/BOH is located on the ground floor of a two-story structure in the center of the CPSC, with the fire station on its north wall and the police station on its south wall (see Figure 1). The roof of the EOC/BOH also serves as a patio (see Picture 1). No openable windows exist in this part of the building.

**Patio That Serves as Roof Of EOC/BOH**

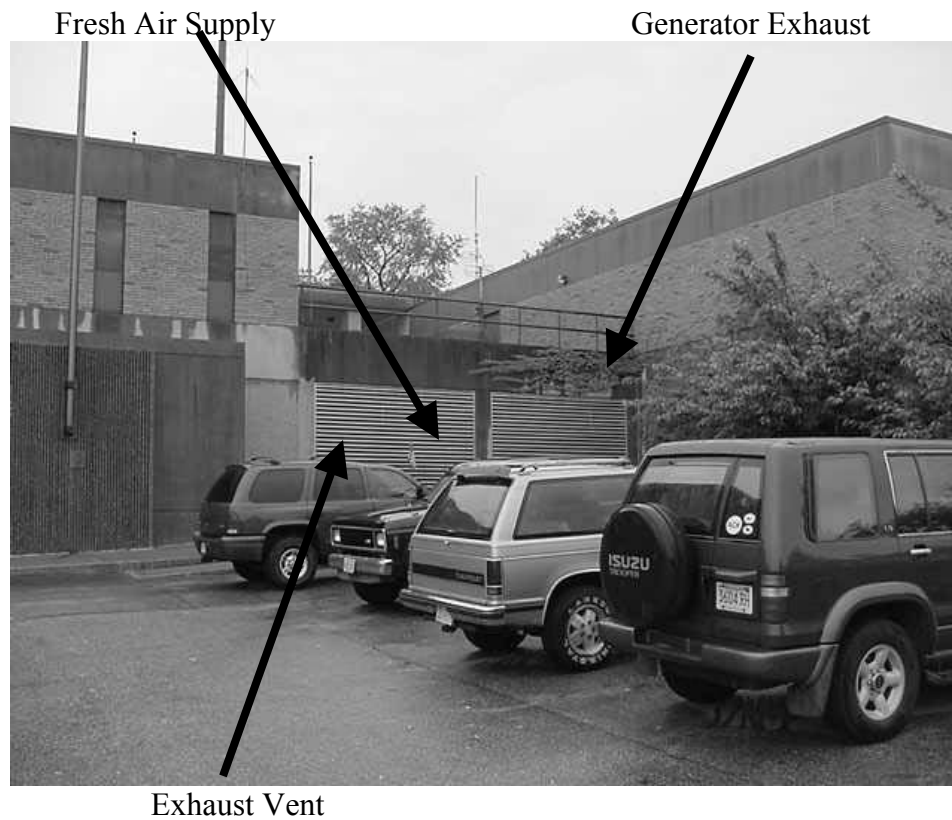
**Picture 2**

Ventilation is provided by a heating, ventilation and air-conditioning (HVAC) system. An air handling unit (AHU) manufactured by the Trane<sup>®</sup> Company (Trane AHU) provides fresh air for all areas within the EOC/BOH. The AHU draws air from the rear of the building through a large air grate (see Picture 2) via ducts. Air is then supplied to EOC/BOH offices by ceiling mounted fresh air diffusers connected to the AHU via ductwork.

Return ventilation is provided by the AHU, which draws air through ceiling-mounted exhaust grilles via ducts. The exhaust for the AHU exits the building through a vent at the rear of the building adjacent to the fresh air intake (see Picture 2). Draw of air

The accumulation of debris within the chiller cavity is directly related to the lack of filtration of outdoor air. The close proximity of the exhaust vent to the general ventilation fresh air intake of the AHU can create conditions where exhaust air may be entrained. Under the current Massachusetts building code, fresh air intakes must be *located at least 2 feet below and 10 feet away from exhaust vents* (SBBRS, 1997; BOCA, 1993). In the present configuration, minimally filtered outdoor air that may contain mold spores can be drawn into and ejected from the chiller chamber, subsequently being entrained by the AHU's general fresh air intake.

Building occupants report periodic odors of fuel exhaust in the EOC/BOH. A room next to the AHU room contains an emergency generator (see Picture 12 and 12A). The exhaust vent for the generator terminates outside above the vents for the AHU (see Picture 2). Under certain wind conditions, it is possible that exhaust from the generator can be entrained by the AHU. Combusted fuel can produce both carbon monoxide and nitrogen dioxide, both of which can be dangerous to health in an indoor environment.

**AHU Fresh Air Intake and Exhaust Vent, Note Location Of Emergency Generator Exhaust Pipes and Vehicles to Fresh Air Intake**

9. Consideration should be give to extending the emergency generator exhaust vent above the level of the patio to prevent exhaust entrainment by the AHU.
10. Implement the corrective actions recommended concerning remediation of bird wastes.
11. Examine the feasibility of taking measures to prevent bird roosting in louvers.

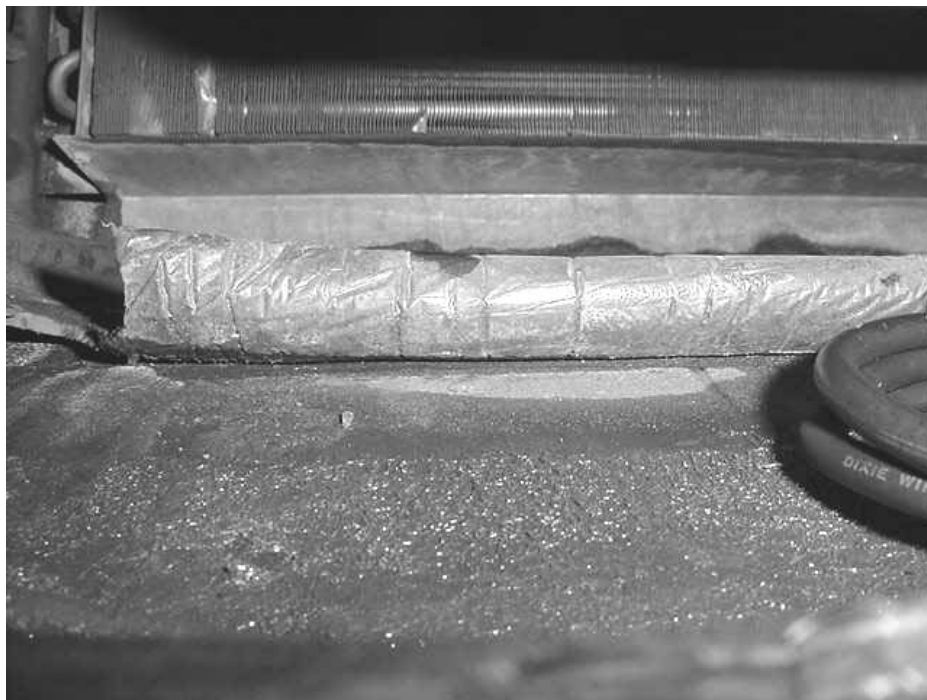
**Picture 3**

The AHU has two compartments with separate fresh air intakes. The upper compartment contains the heating/cooling coil. The lower cabinet contains the chiller that is activated during hot weather. Both cabinets contain drip pans to drain accumulated condensation from the coils and cold surfaces of the chiller. The purpose of the lower fresh air intake vent on the exterior of the building was to provide cooling for the Trane units' chiller compressor located in the base of the AHU (see Figure 2). The drip pans within the chamber containing the air conditioning equipment were heavily

coated with debris (see Picture 3). This debris, with the addition of condensation, would be expected to be a ready mold growth medium. While mold growth was not apparent, the operation of this system could result in mold growth in the chamber when the HVAC system is switched to its cooling cycle during summer months.

**Debris in AHU Drip Pan**

1. The drip pans in the AHU should be disinfected and cleaned. Thoroughly disinfect and clean other water accumulation surfaces within the AHU.
2. Remove containers filled with water from the AHU room.

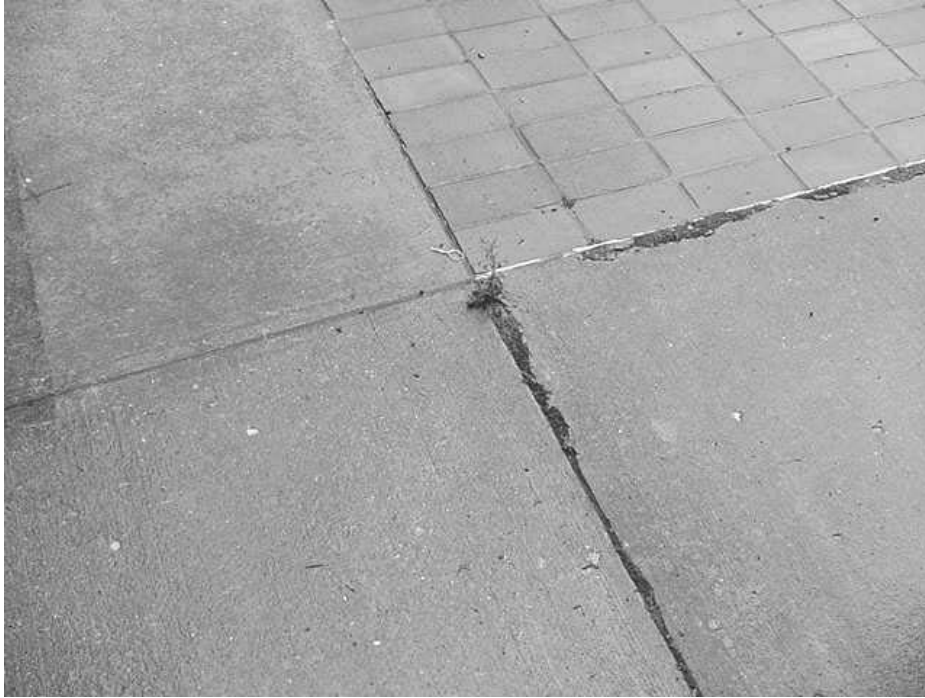
**Picture 4**

Water damage to ceiling tiles was observed directly below the patio in the Weights & Measures storeroom. Cement and brick of the patio was damaged or missing.

Plants were also found growing between slabs and brick (see Picture 4). The EOC/BOH was assessed during a rainstorm. Pooling water was observed in the patio, despite the presence of a drain (see Picture 5). Cracks on brick and cement as well as plant colonization can serve as means for water to penetrate into the Weights & Measures storeroom.

**Damaged/Missing Caulking in Patio Cement, Brick**

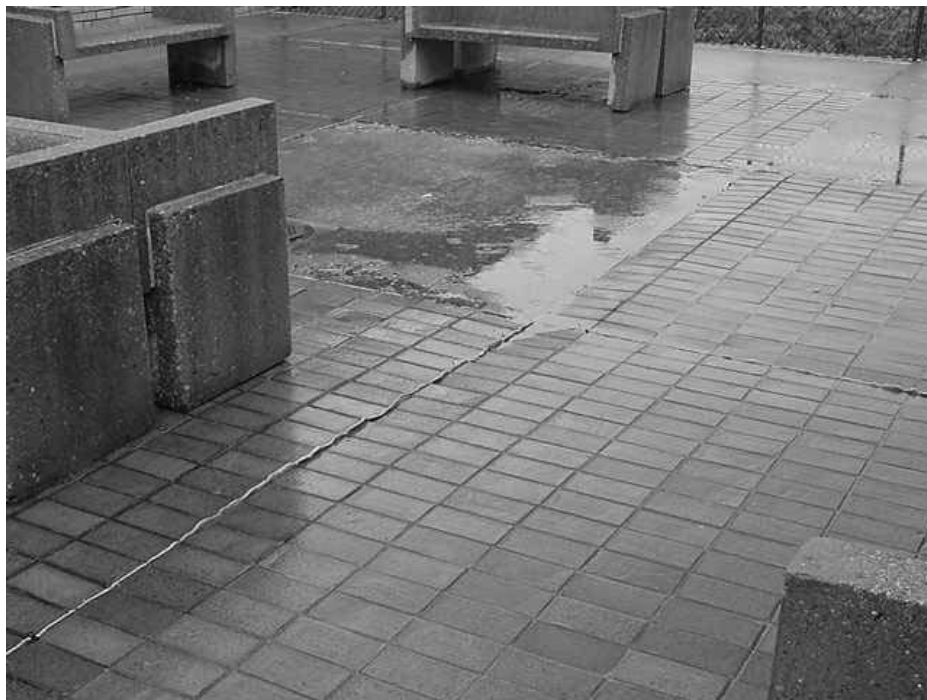
**Picture 5**

**Standing Water on Patio**

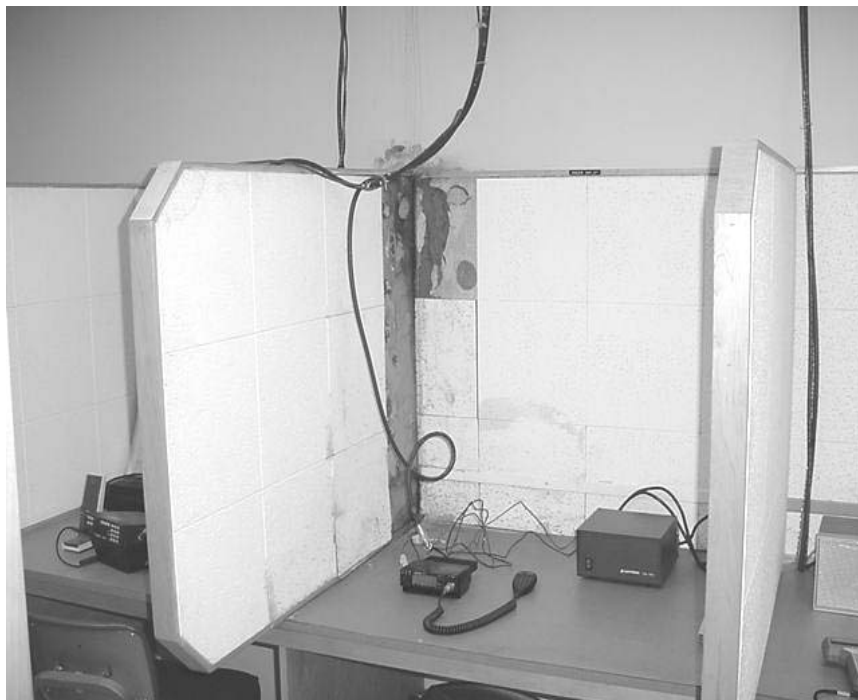
**Picture 6**

The radio room had a substantial number of water damaged/mold colonized acoustical tiles and damaged plywood (see Pictures 6 and 7). The water source that moistened the acoustical tiles appears to be utility holes that have since been sealed (see Picture 8). The acoustic tiles are glued directly to the plywood ceiling. Replacement of these ceiling tiles is difficult, since their removal appears to necessitate the destruction of the tile, which can result in the aerosolization of particulates. Ceiling tiles, acoustical

**Water Damaged Acoustic Tile**

8. Replace water damaged ceiling tiles (for more information see **long-term measures** below).

1. Water-damaged ceiling tiles should be replaced. These ceiling tiles can be a source of microbial growth and should be removed. Source of water leaks (e.g., window frames and roof) should be identified and repaired. Examine the non-porous surface beneath the removed ceiling tiles and disinfect with an appropriate antimicrobial.
2. Replace the bird screen in the fresh air intakes to a wider gauge to prevent debris accumulation.

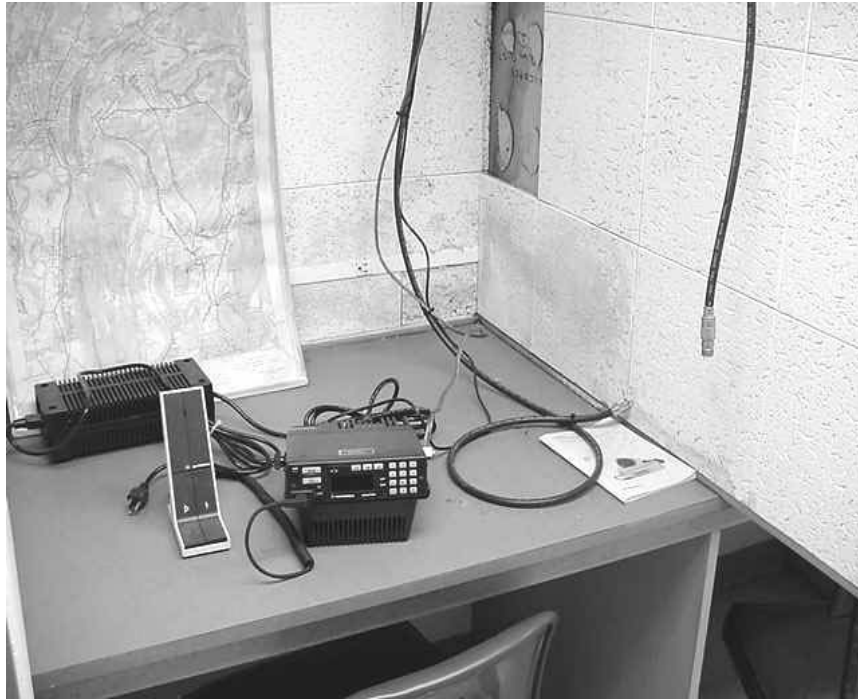
**Picture 7**

**Water Damaged Acoustic Tile**

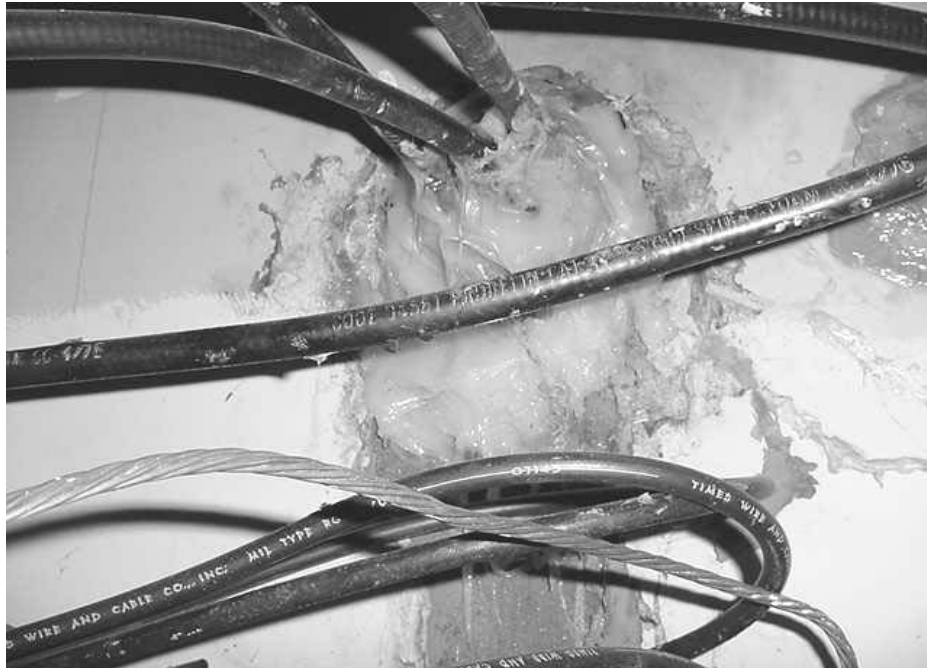
**Picture 8**

**Sealed Pipes above Water Damage**

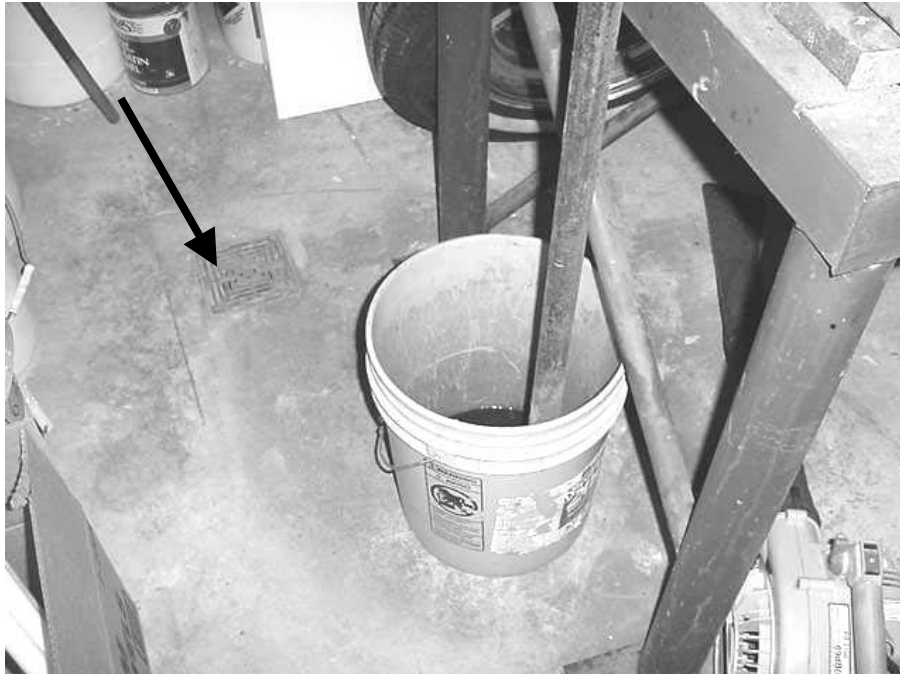
**Picture 9**

A bucket of standing water was found in the AHU room (see Picture 9). The source of water in the bucket is condensation from the AHU. Standing water can be a source of microbial growth and associated odors, which can be problematic since the condensation drain is depressurized (drawing air). If microbial growth exists, odors and associated particulates can be drawn back into the AHU and distributed into the EOC/BOH.

A floor drain exists in the AHU room, presumably to drain condensation. The AHUs provides air-conditioning during warm months. AHUs that provide air-conditioning require the installation of condensation drains to prevent water build up inside the casing and ductwork. The condensation drain for these units terminates near the floor drain that is connected to the building drainage system (see Picture 9). Drains are usually designed with traps in order to prevent sewer odors/gases from penetrating into occupied spaces. When water enters a drain, the trap fills and forms a watertight seal. Without a periodic input of water (e.g., every other day), traps can dry, preventing a watertight seal. During the heating season, the AHU does not produce condensation, resulting in the traps of the condensation drains drying out. The AHU was found to be drawing air into each unit through the condensation drain. With the condensation drain acting as a vacuum, odors from the floor drain without a water-sealed trap can be drawn into the AHU and distributed to occupied areas in the EOC/BOH.

**Bucket Collecting Condensation, Note Standing Water and Location Of Drain**

3. Ensure water is poured into the AHU floor drains every other day to maintain the integrity of the traps.
4. Seal the condensation drain for AHU during the heating season. Please note that the drain must be unsealed during the air-conditioning season in order to drain condensation. **Failure to remove condensation drain seals can result in water back up into the AHU and produce mold growth.**

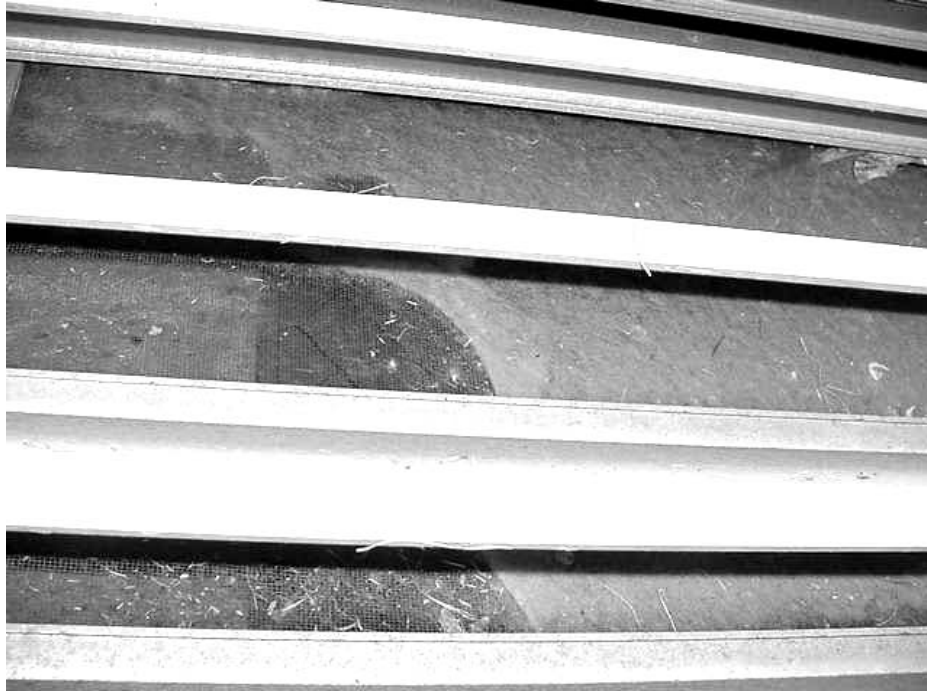
**Picture 10**

The fresh air intake for the AHU is covered with a fine mesh screen to serve as a bird screen, which rapidly accumulates outdoor particles (see Picture 10). This accumulation can serve as a source of microbial growth as well as prevent airflow into the AHU.

**Fresh Air Intake Bird Screen Covered in Accumulated Materials**

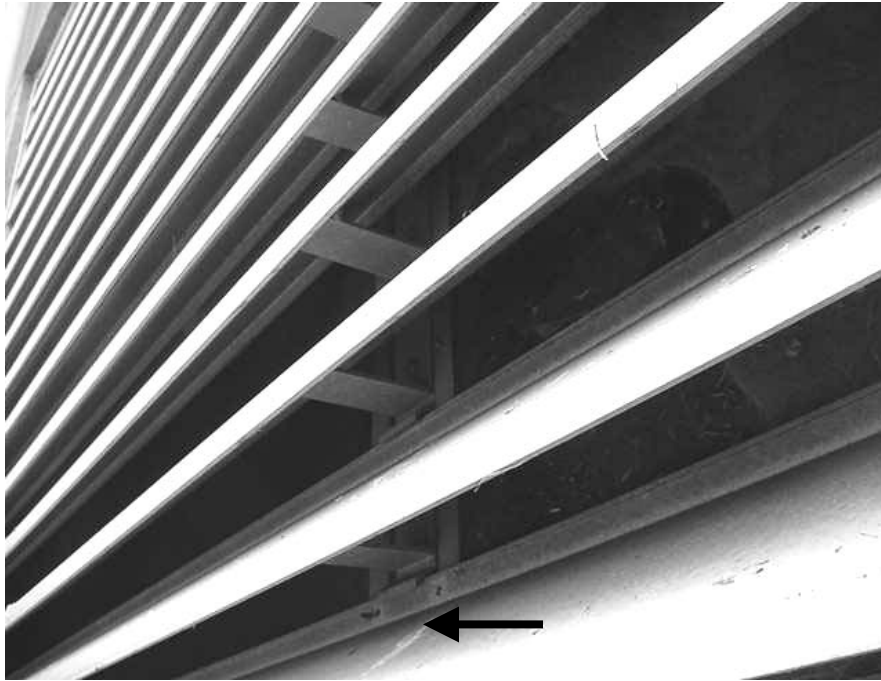
**Picture 11**

In some areas the louvers were coated with bird waste. Each louver of the fresh air intake is supported by a metal triangle large enough to fit a bird the size of a sparrow. Bird wastes were observed inside exhaust vents along the west exterior wall of the building (see Picture 11). Under these conditions, it is possible for molds and allergenic materials associated with bird wastes and feathers to be entrained by the air intake. Bird

wastes in a building raise concerns over diseases that may be caused by exposure to bird wastes. The need for clean up of bird waste and appropriate disinfection is imperative.

**Bird Waste on HVAC System Louvers**

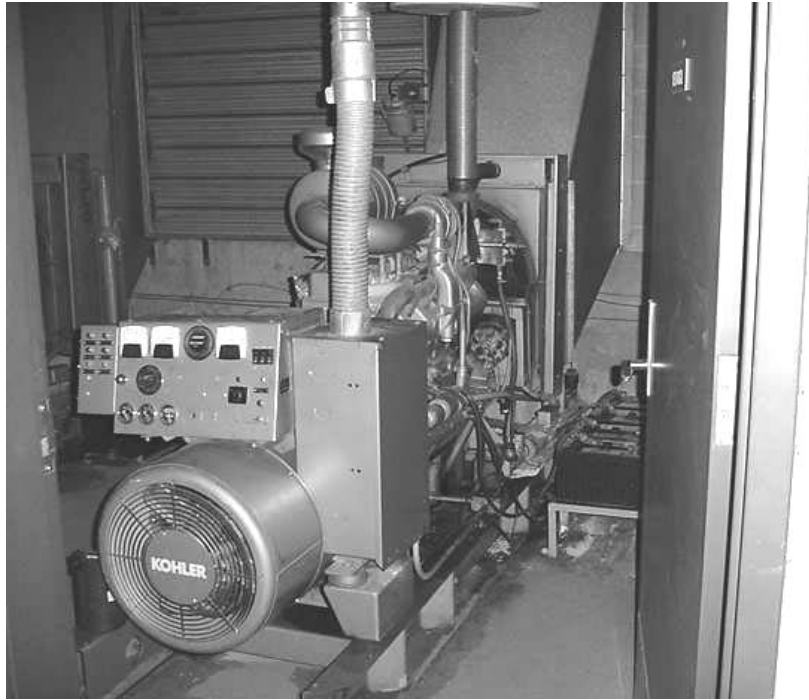
**Picture 12**

**Emergency Generator Room Next to AHU Room**

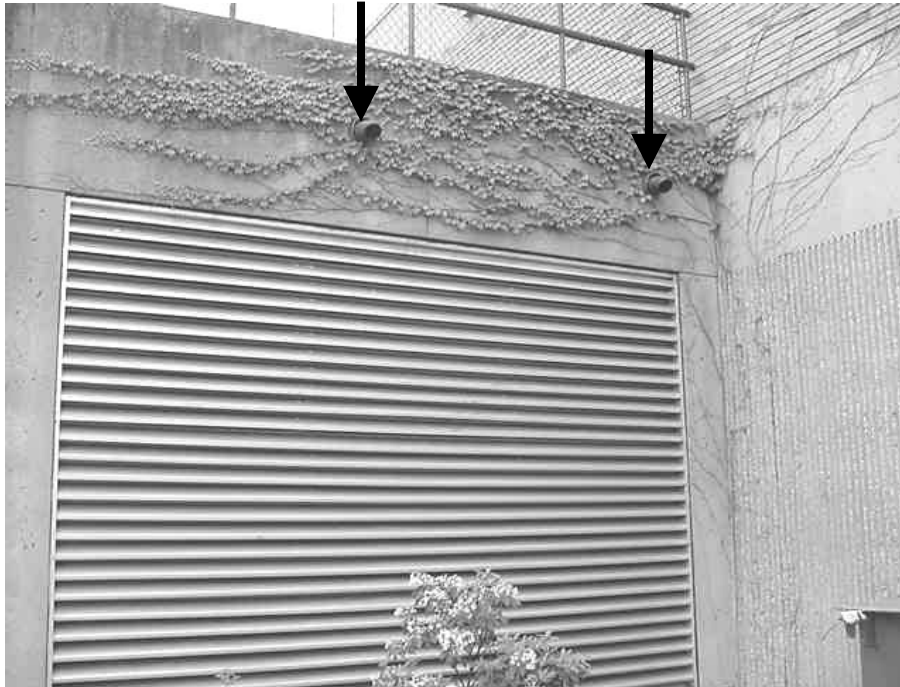
**Picture 12A**

**Close-Up of Emergency Generator Make Air Vent and Exhaust Pipes**
